## The Conservancy Association

RE: Comments on Penfold Park Enhancement Project Profile

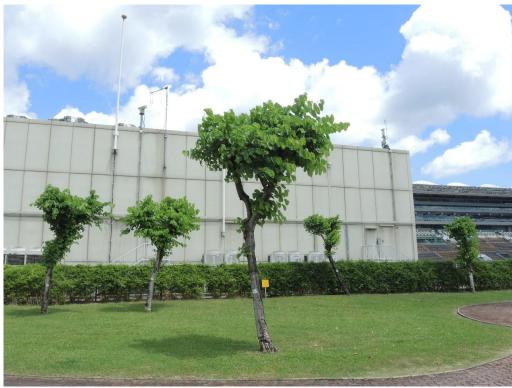
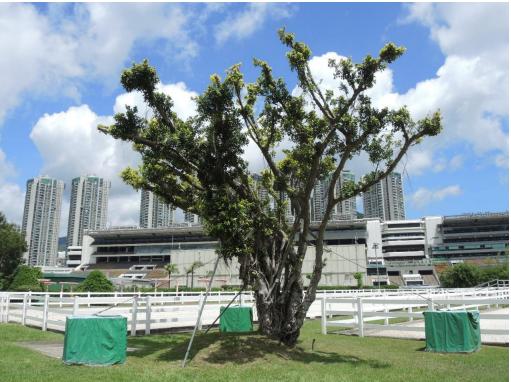
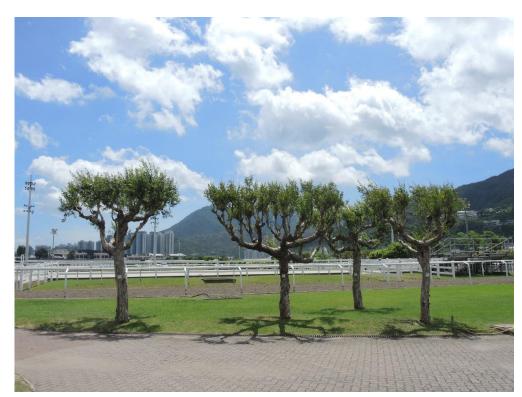
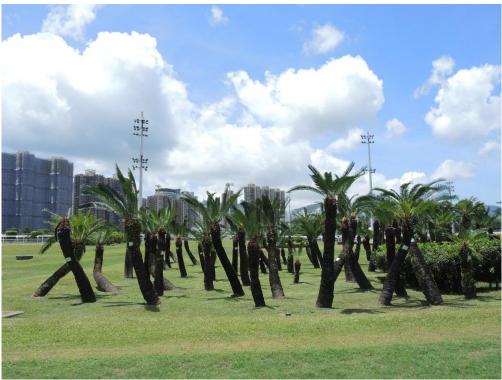
In terms of updated arboricultural standard, trees in the study sites were not in good condition. Some trees were in poor structural conditions despite fair health conditions. Some trees were unnecessarily topped while some had pruning cuts poorly done (Figure 1-4). These have caused serious tree deformation and created weak structure on many trees. Topped trees had crown size much smaller than normal trees, and this would reduce the opportunity to offer habitat for wildlife.

Figure 1-4 Some trees were unnecessarily topped while some had pruning cuts poorly done. These have caused serious tree deformation and created weak structure on many trees

Although new trees were proposed to replace those felled trees, tree conditions would still remain poor with the above inappropriate tree management. Apart from location, implementation programme, maintenance and management schedules, etc., proper pruning proposal should also be included in the compensatory planting proposal. Indeed proper pruning proposals would be submitted for the retained and transplanted tree according to the Project Profile, and such inclusion would further enhance proper implementation of landscape and visual mitigation, and ensure comprehensive tree management in future.

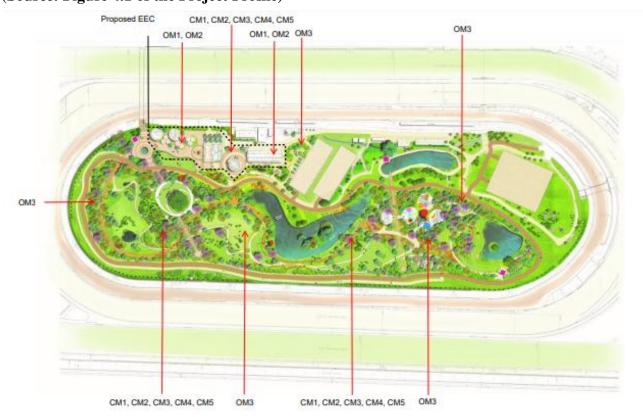
be replaced by not only Equine Experience Centre but also landscape enhancement work. From landscape and visual aspects, the area of lawn would be reduced and the overall landscape of Penfold Park would be altered. For example, the photomontage in Figure 3.1B of the Project Profile showed that new trees can be greatly dominated in the existing open lawn. The proposed landscape and visual mitigation measures in Figure 4.1 of the Project Profile even imply that the open lawn would be loss in large scale (Figure 5).

Figure 5 The proposed landscape and visual mitigation measures, with many new trees planted in the site, seems to imply that the open lawn would be loss in large scale (Source: Figure 4.1 of the Project Profile)

Some landscape enhancement measures, from ecological point of view, would create more diverse habitat for wildlife in future. While we agree that these measures (such as tree planting, butterfly garden, etc.) create opportunities for habitat enhancement, open lawn under proper management could serve similar function. More importantly, landscape and recreation value of the open lawn in Penfold Park should not be neglected. To balance function of various habitats in the site, there should be flexibility in maintaining certain proportion of open lawn in the landscape design proposal.
