RE: Comments on the Section 16 Application No. A/NE-FTA/201

The Conservancy Association (CA) OBJECTS to the captioned application.

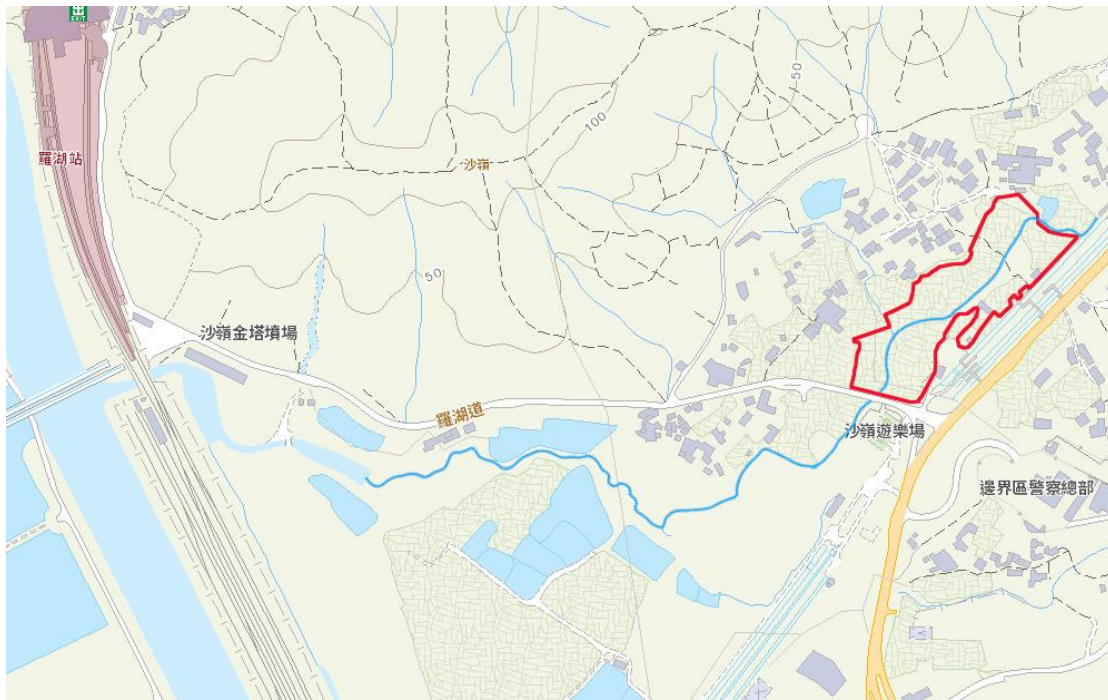
Figure 1 A watercourse (marked in light blue) is running from the subject site (marked in red) to the AGR zone in the south of Lo Wu Road

We are also very disappointed that the ecological impact assessment (EcoIA) fails to take account of off-site ecological impacts. For example, a watercourse is running from the subject site to the AGR zone south of Lo Wu Road (Figure 1). Although land filling activities have been observed in that area few years ago, we note from the aerial photo that the area comprise fish pond, dry and wet agricultural land (Figure 2) which might still be of considerable ecological value. Since there would be direct loss of this watercourse, we worry that it would also disturb fish pond and agricultural land in the area.

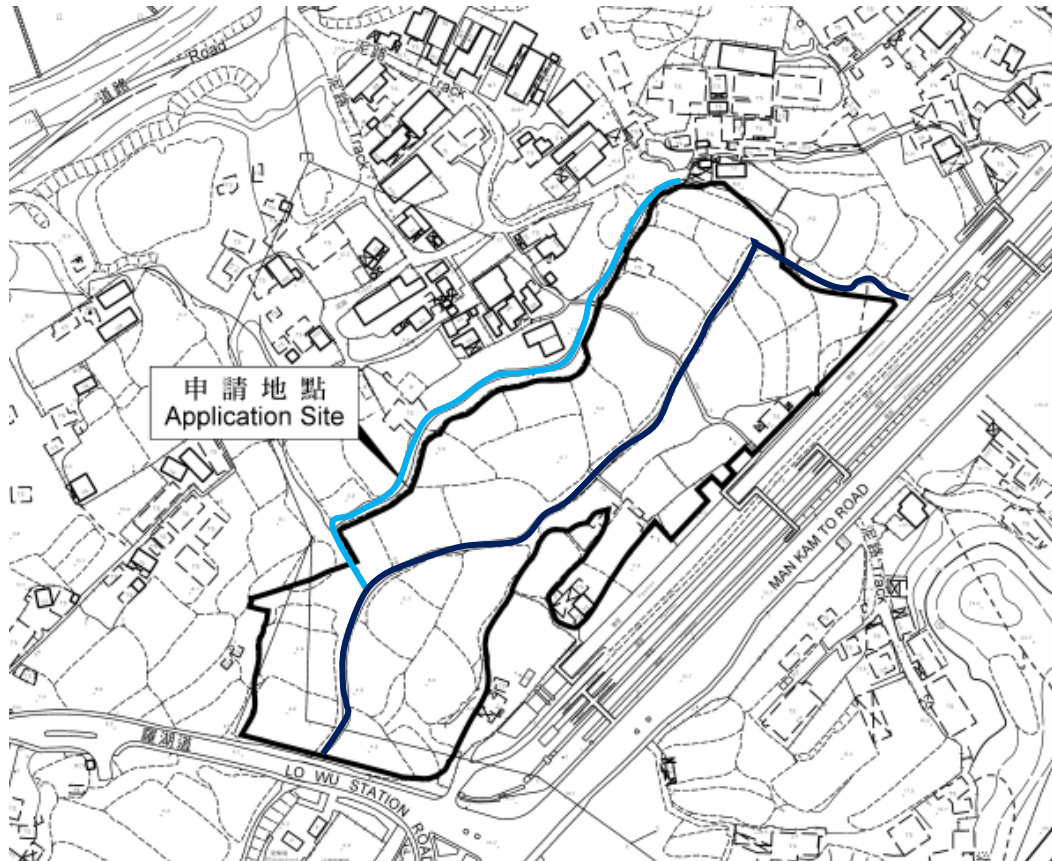
Figure 3 Another watercourse (marked in light blue) is found very close to the northwest boundary of the subject site and would eventually connect to the lower part of the watercourse (marked in dark blue) within the site

Meanwhile, another watercourse is found very close to the northwest boundary of the subject site. Likewise, the EcoIA gives no attempts in evaluating any potential disturbance on the watercourse. Indeed this watercourse would eventually connect to the lower part of the watercourse within the site (Figure 3), and then down to the AGR zone in the south of Lo Wu Road. Even though this watercourse lies outside the subject site, potential ecological impact on this watercourse should not be ignored.
