The Conservancy Association

13th January 2023

Objection to PWP Item No. 7471RO The Establishment of an Agricultural Park in Kwu Tung South (Phase 2) – Road Works

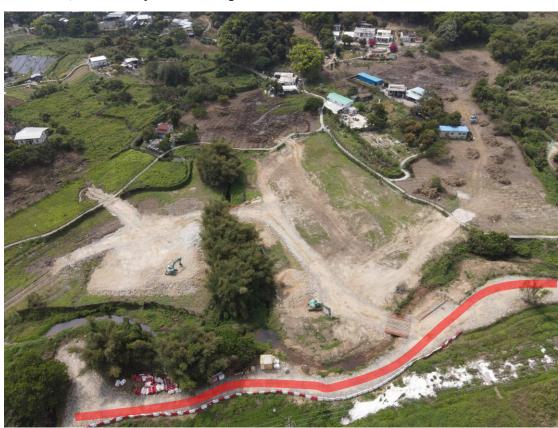
Figure 1 During construction of the Agri-Park Phase 1, including the main road work (alignment shaded in red), many additional temporary access and work site were formed. During construction phase, topsoil was either be excavated, covered by rockfill or paved with cement

- Similar to the road work in Agri-Park Phase 1, the proposed alignment would cause serious fragmentation of farmland in Tsiu Keng.
- Natural stream and irrigation ditches spotted along the alignment would be affected.
- With reference to Agri-Park Phase 1, many additional temporary access and work site were formed to facilitate road work. During construction phase, topsoil was either be excavated, covered by rockfill or paved with cement (Figure 1). These cause difficulties for topsoil to be restored.
- Again, with reference to Agri-Park Phase 1, even though existing farmers affected by the road work were supposed to be relocated in Agri-Park for farm rehabilitation.

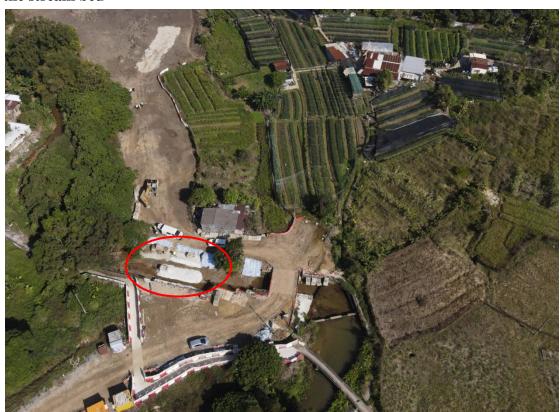
During construction of a temporary bridge for the main road in Figure 2 Agri-Park Phase 1, some concrete foundation (circled in red) was once formed at the stream bed

- We have learnt from the road work in Agri-Park Phase 1 that temporary bridge has to be erected across natural stream and some concrete foundation was once formed at the stream bed (Figure 2). It is still very worrying that similar condition would happen again as several vehicular bridges are now proposed in the plan, and then some temporary bridges have to be erected again prior to those permanent bridges. In this case, there would be disturbance on stream bed during construction phase.

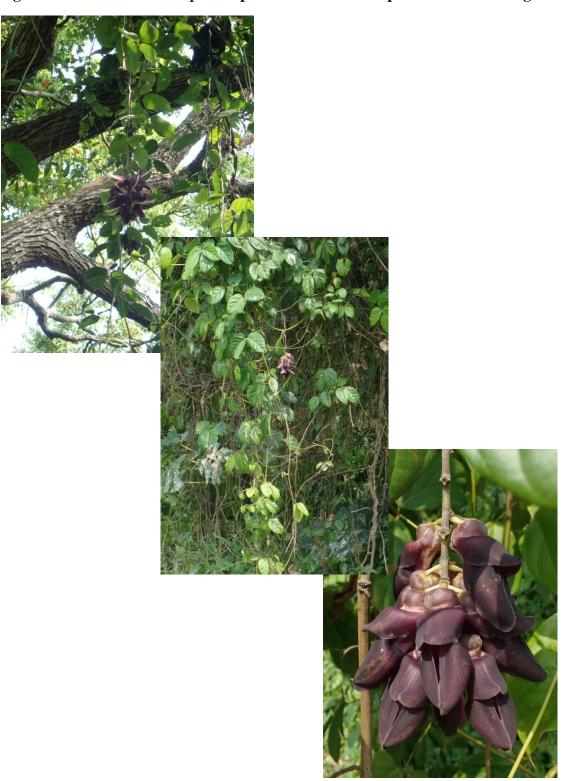
Figure 3-5 Mucuna championii spotted in several tree patches in Tsiu Keng

- We are concerned that the proposed road section would be in direct conflict with mature trees and species of conservation species, particularly Mucuna championii (Figure 3-5), a tall woody climber spotted in several tree patches in Tsiu Keng.
